Bioventing at
Operable Units 5, 8, 9, 10, and 11

Loring Air Force Base
SEMIANNUAL PERFORMANCE REPORT
August — December 1997

March 1998
Revision B

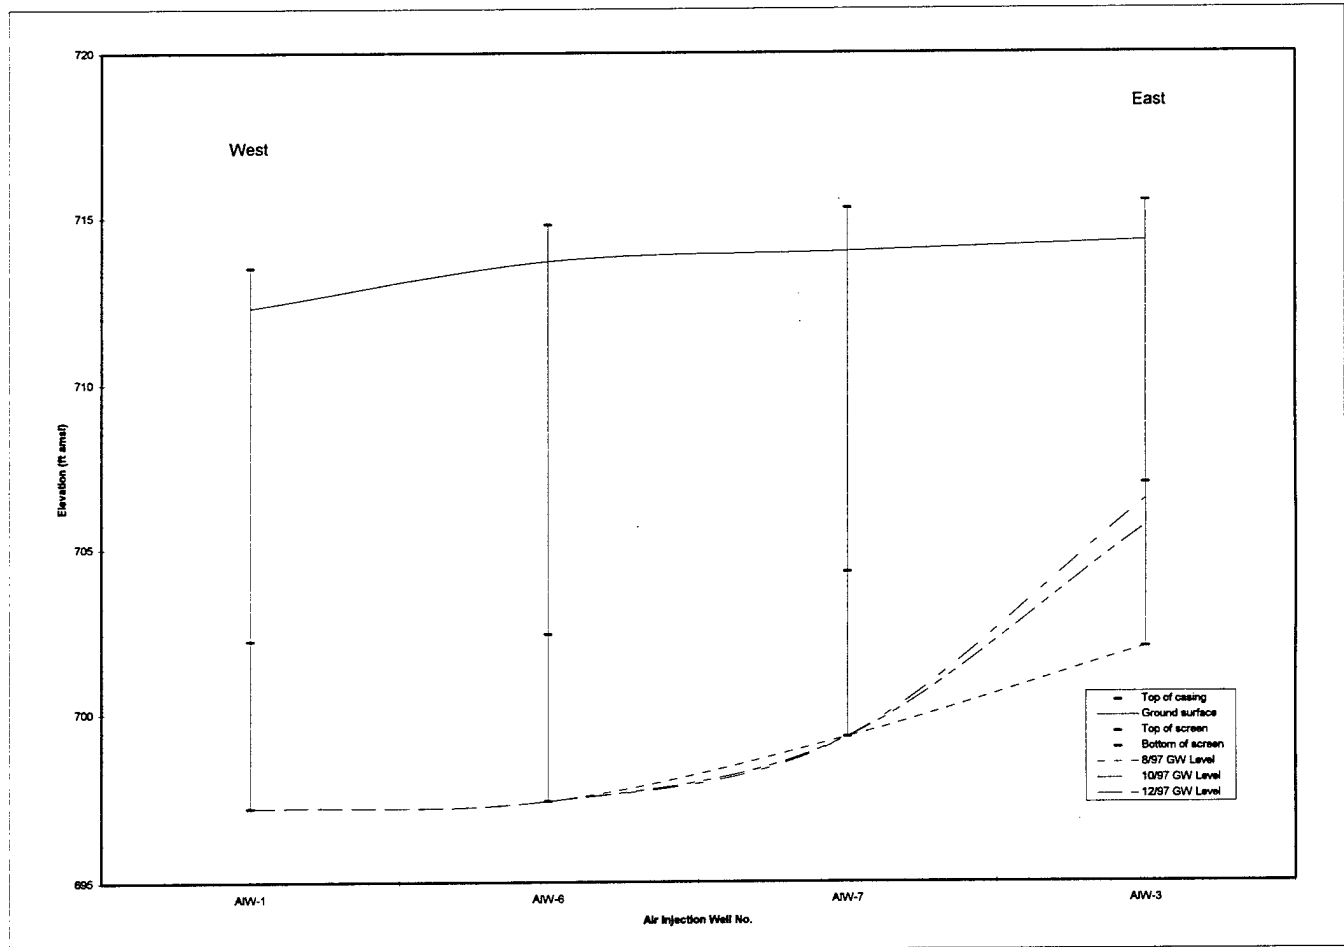
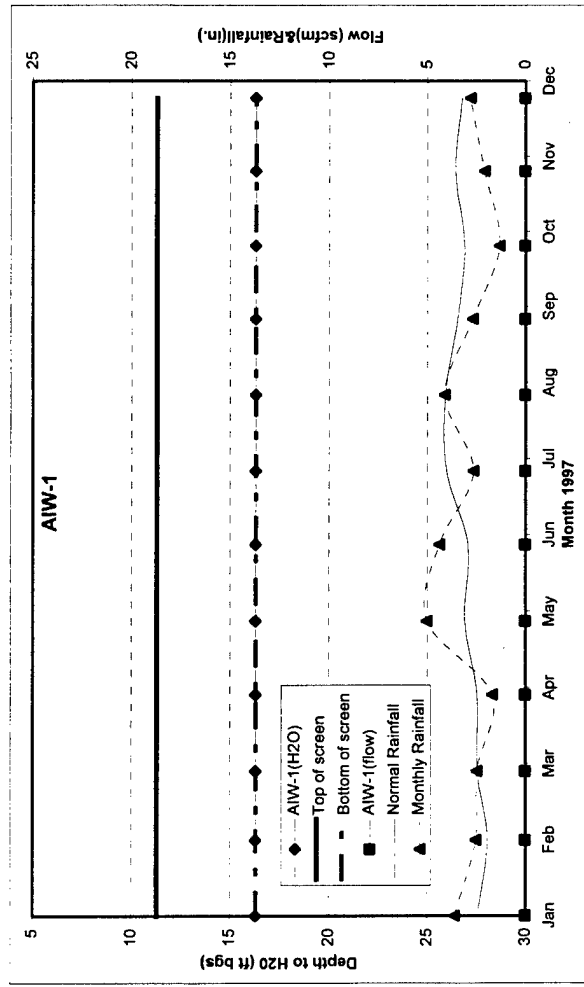
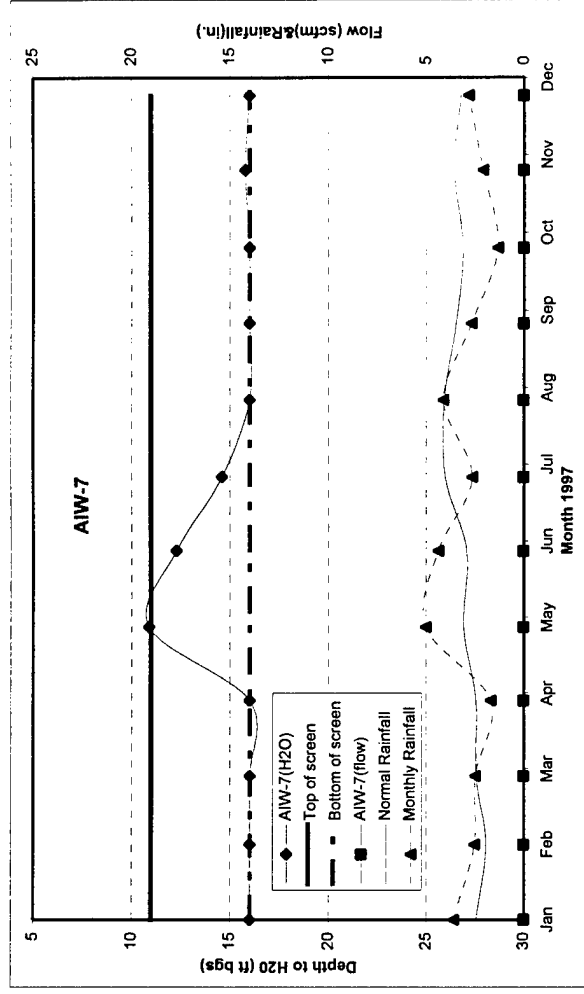
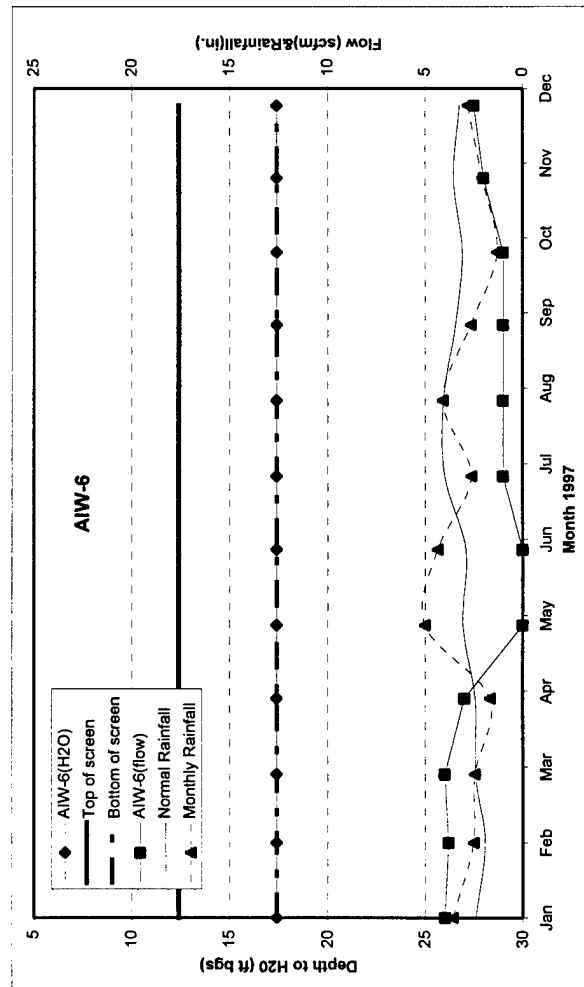
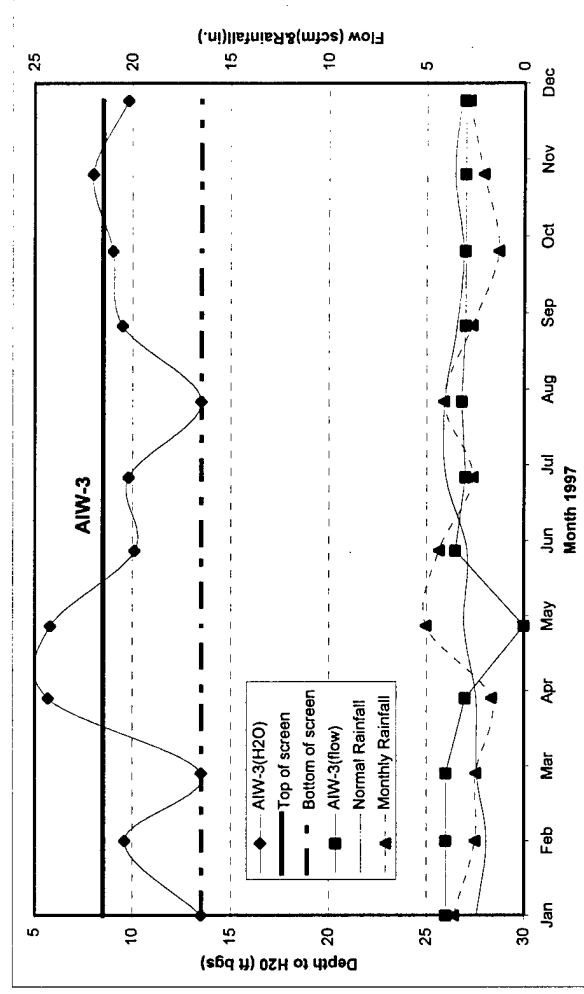
West / East Cross Section at Entomology Shop

Figure 6-2 ES Groundwater/Air Flow Relations Along West/East Section

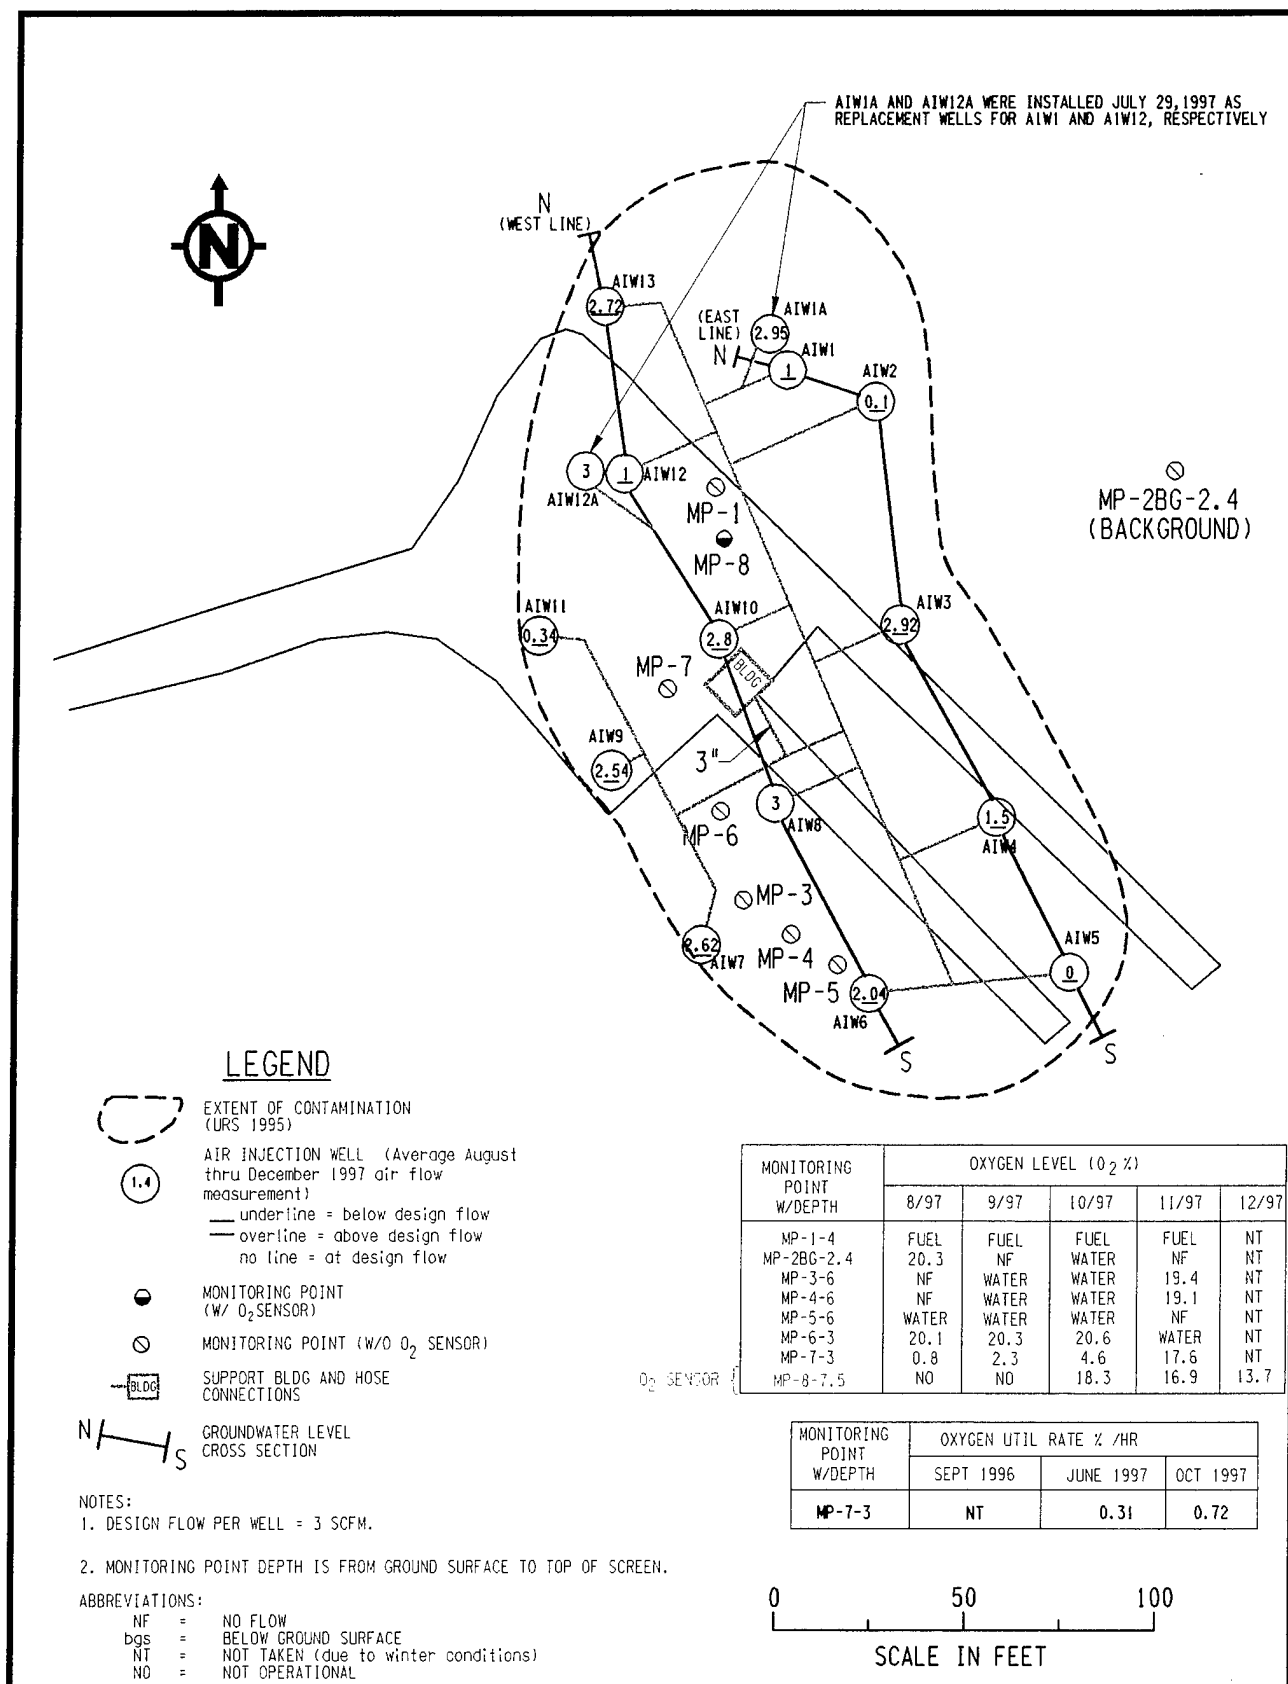
Figure 7-1
FJETC Biovent System Layout
and Average Wellhead Flow

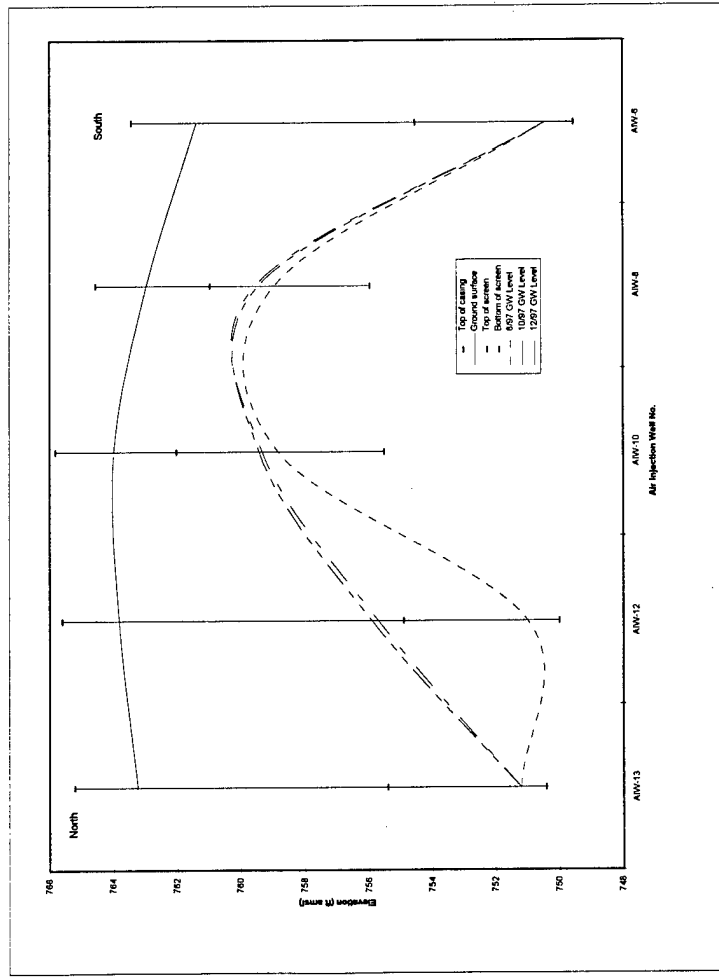
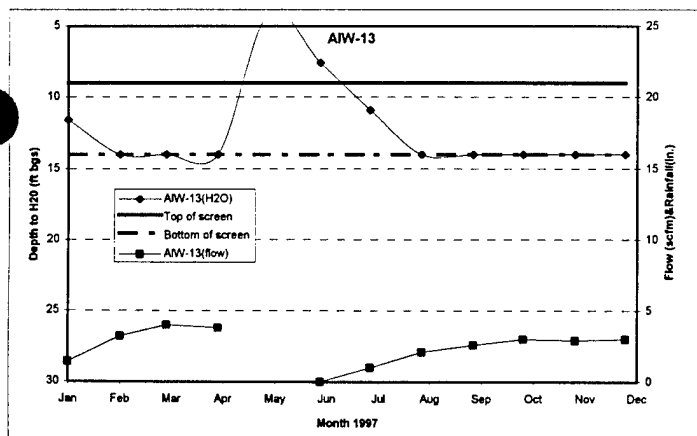
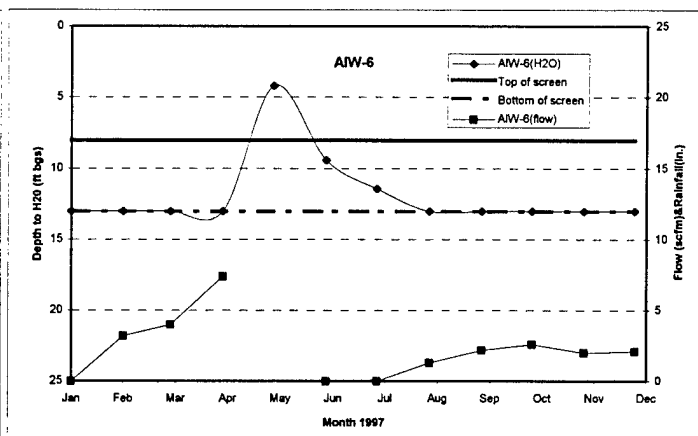
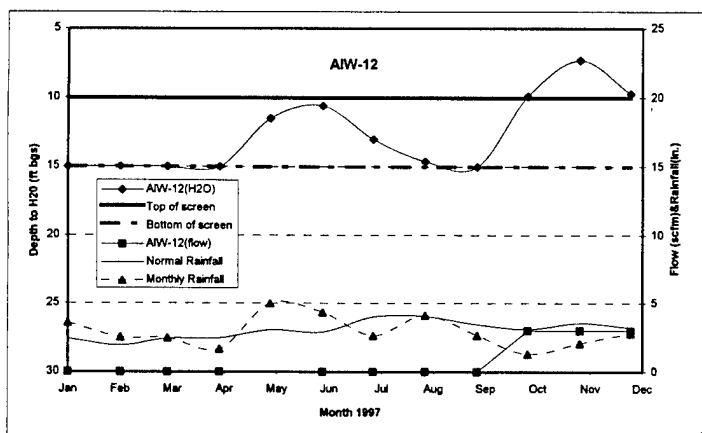
North / South Cross Section at FJETC - Westline

Figure 7-2 FJETC Groundwater/Air Flow Relations Along North/South Section (Westline)

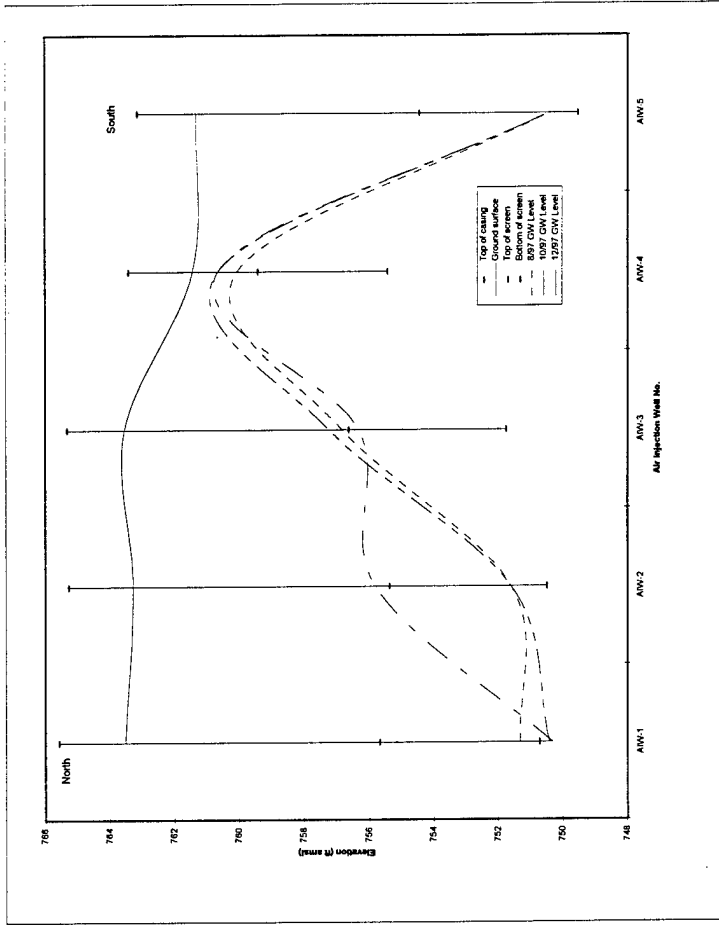
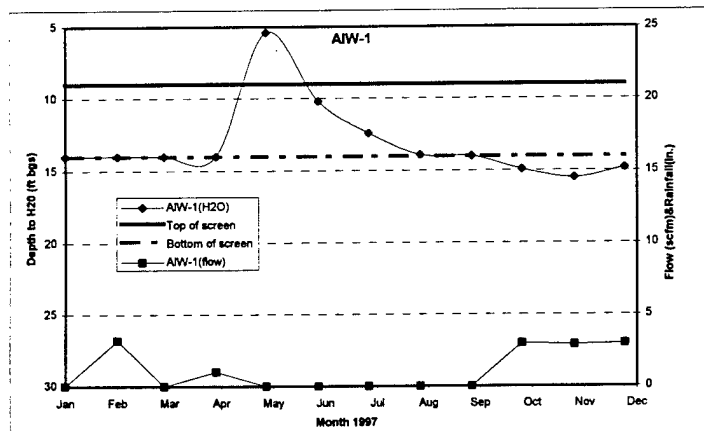
North / South Cross Section at FJETC - Eastline

Figure 7-3 FJETC Groundwater/Air Flow Relations Along North/South Section (Eastline)

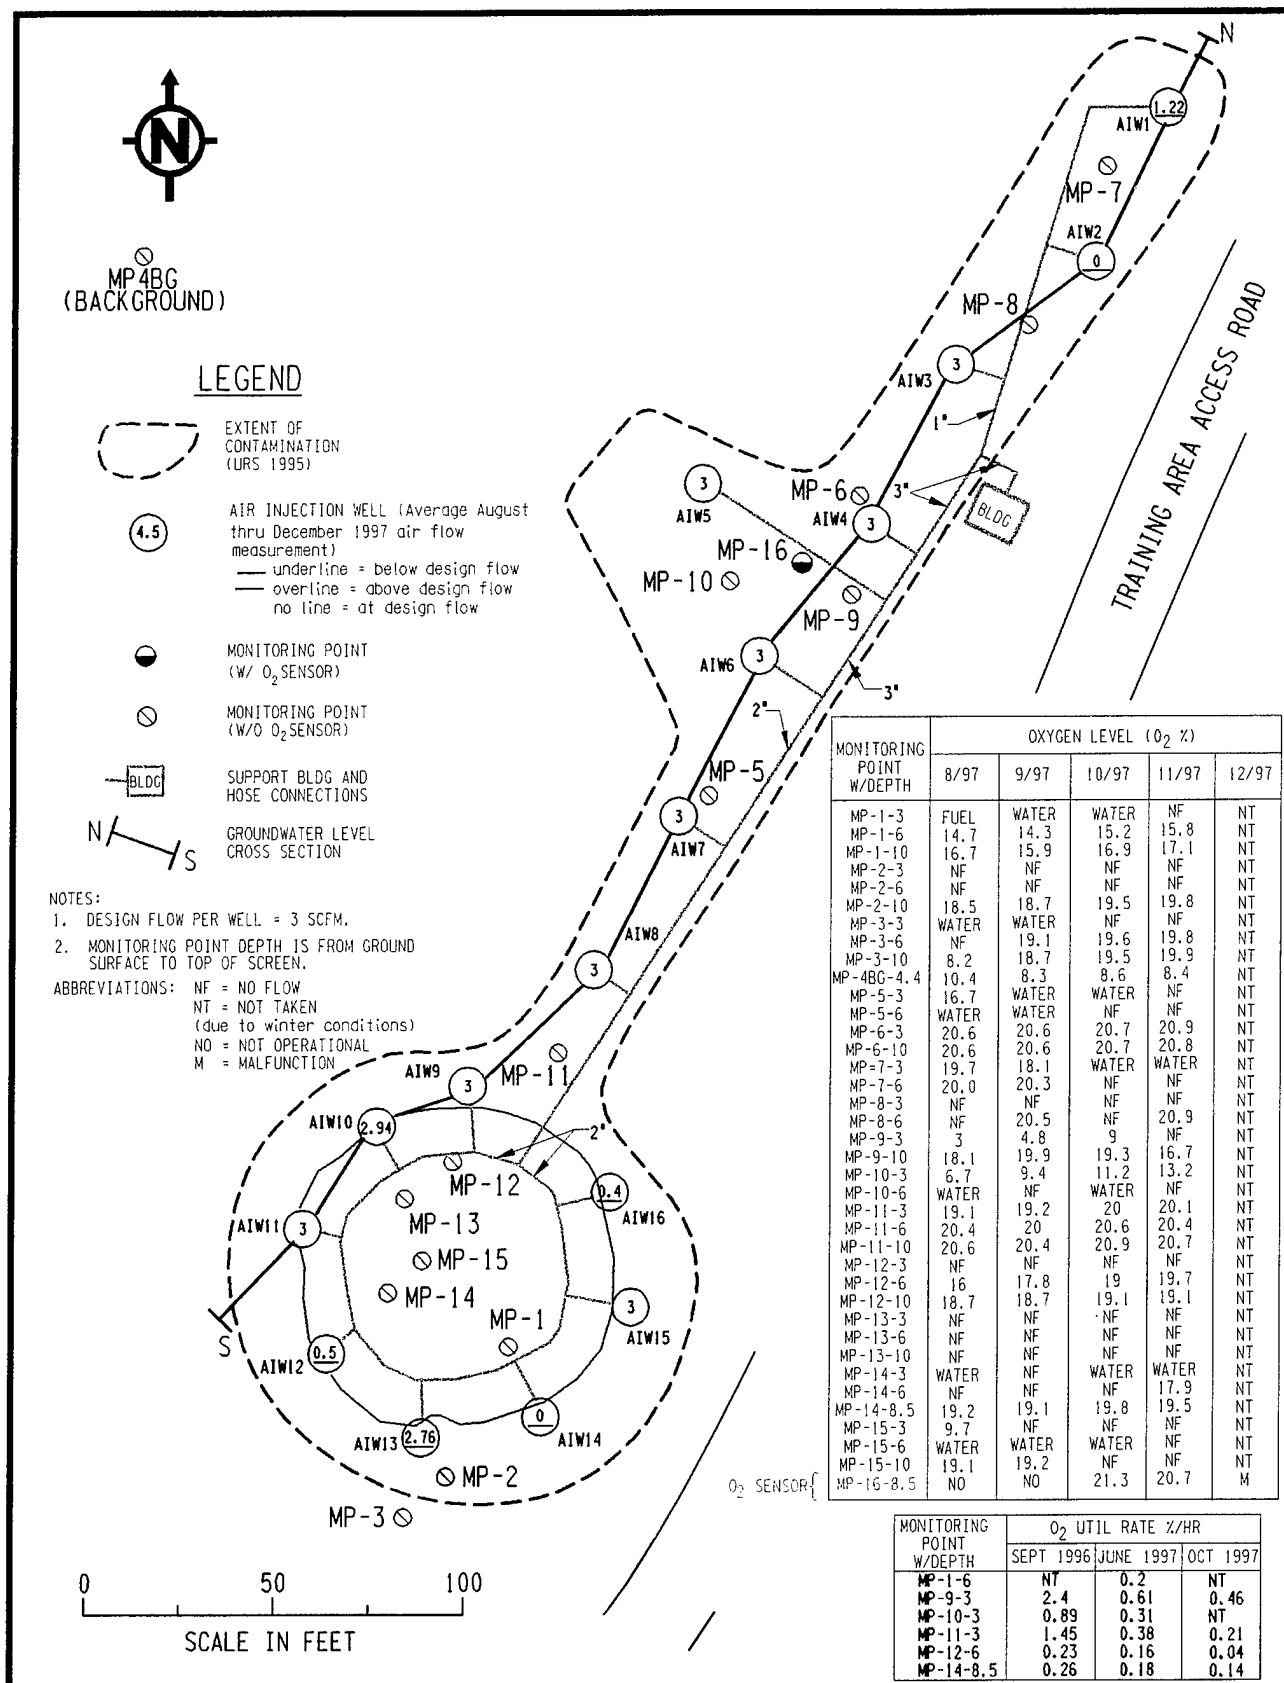
Figure 8-1
FTA Biovent System Layout
and Average Wellhead Flow

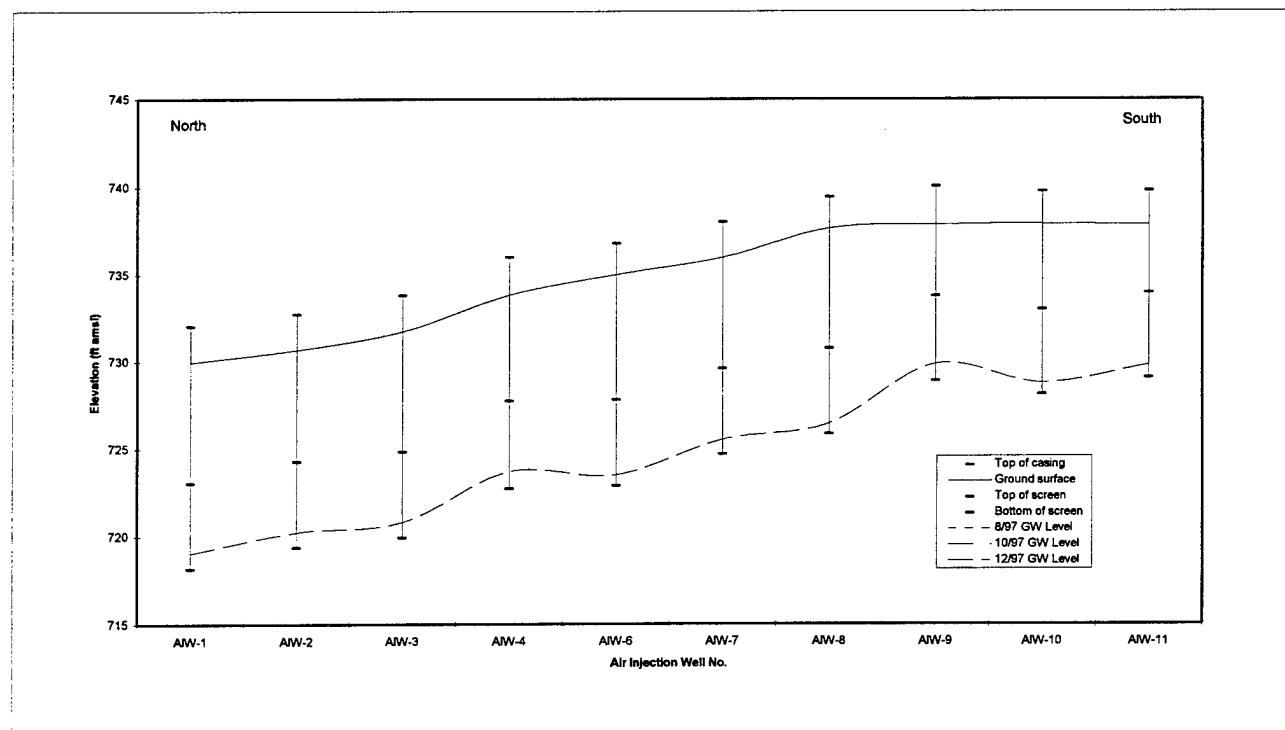
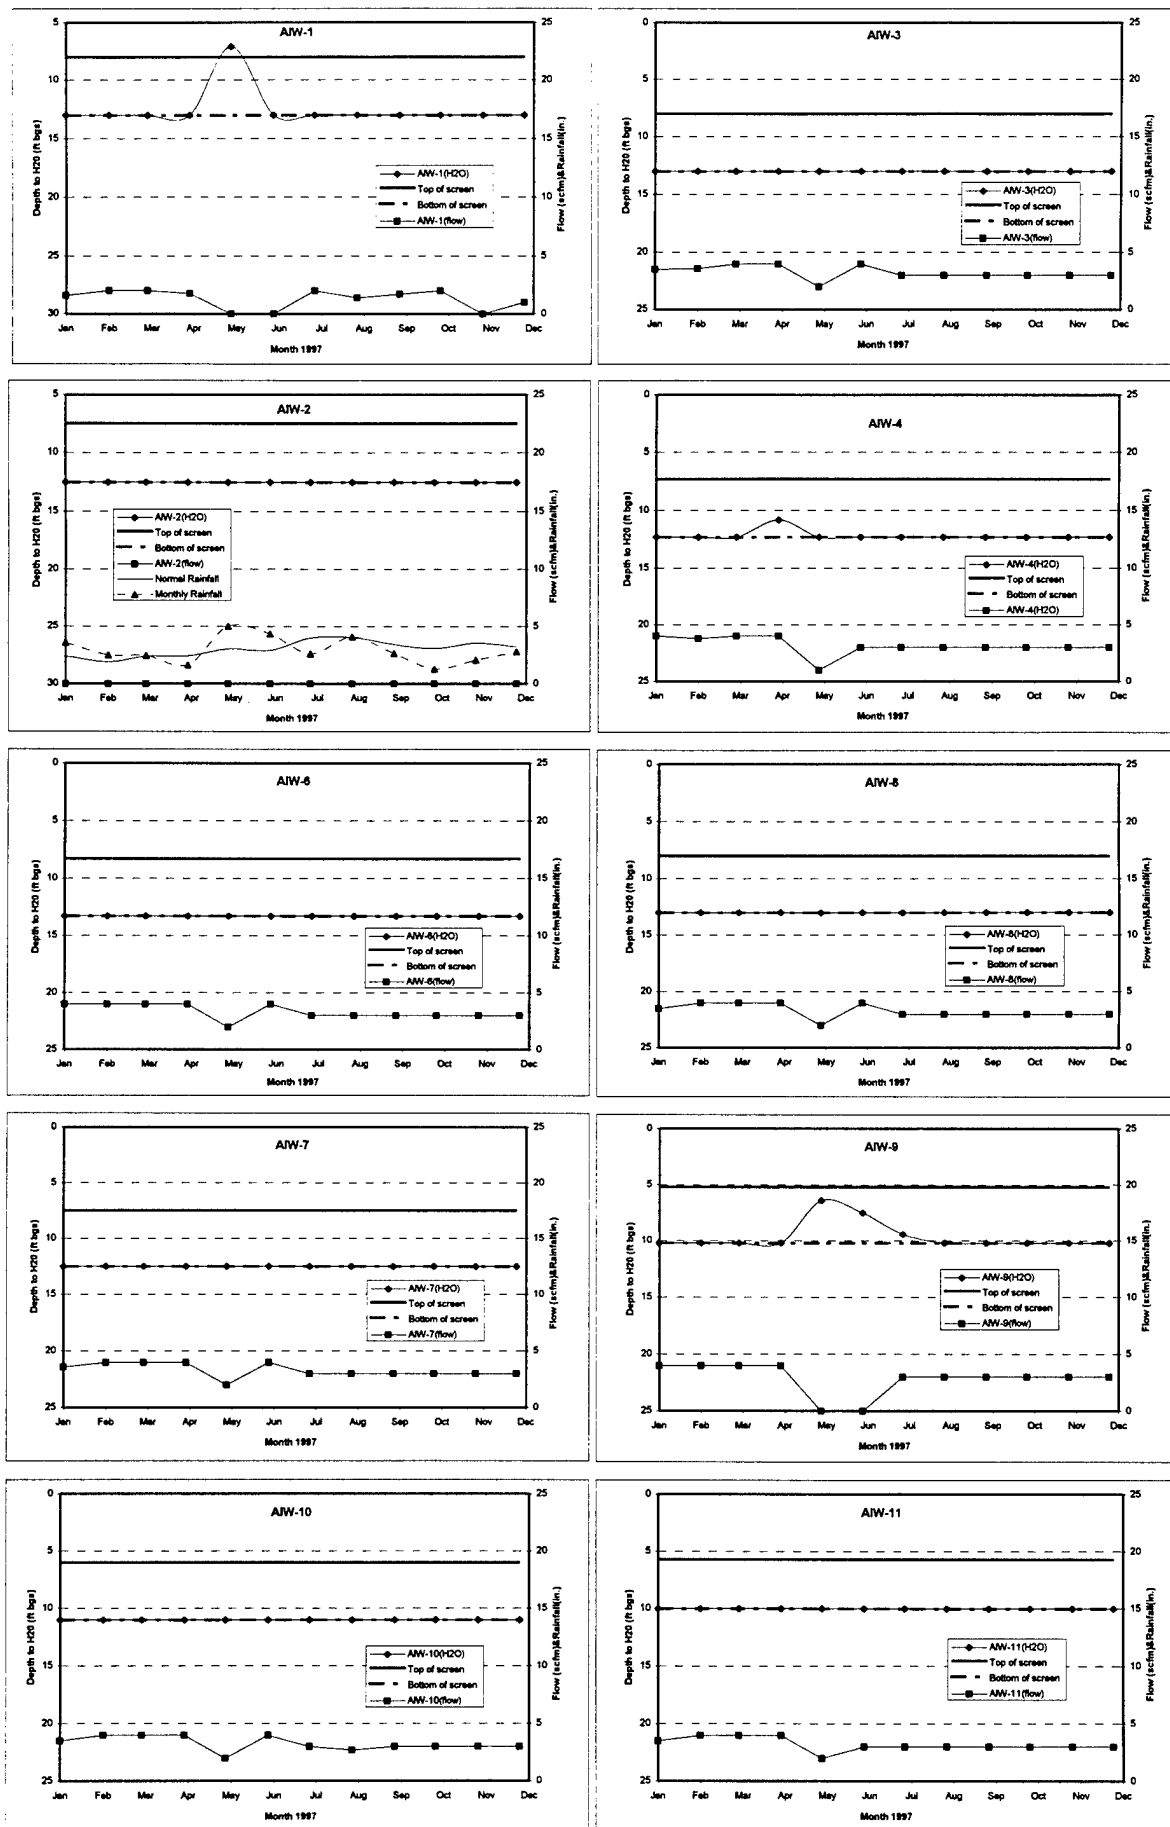
North / South Cross Section at Fire Training Area

Figure 8-2 FTA Groundwater/Air Flow Relations Along North/South Section

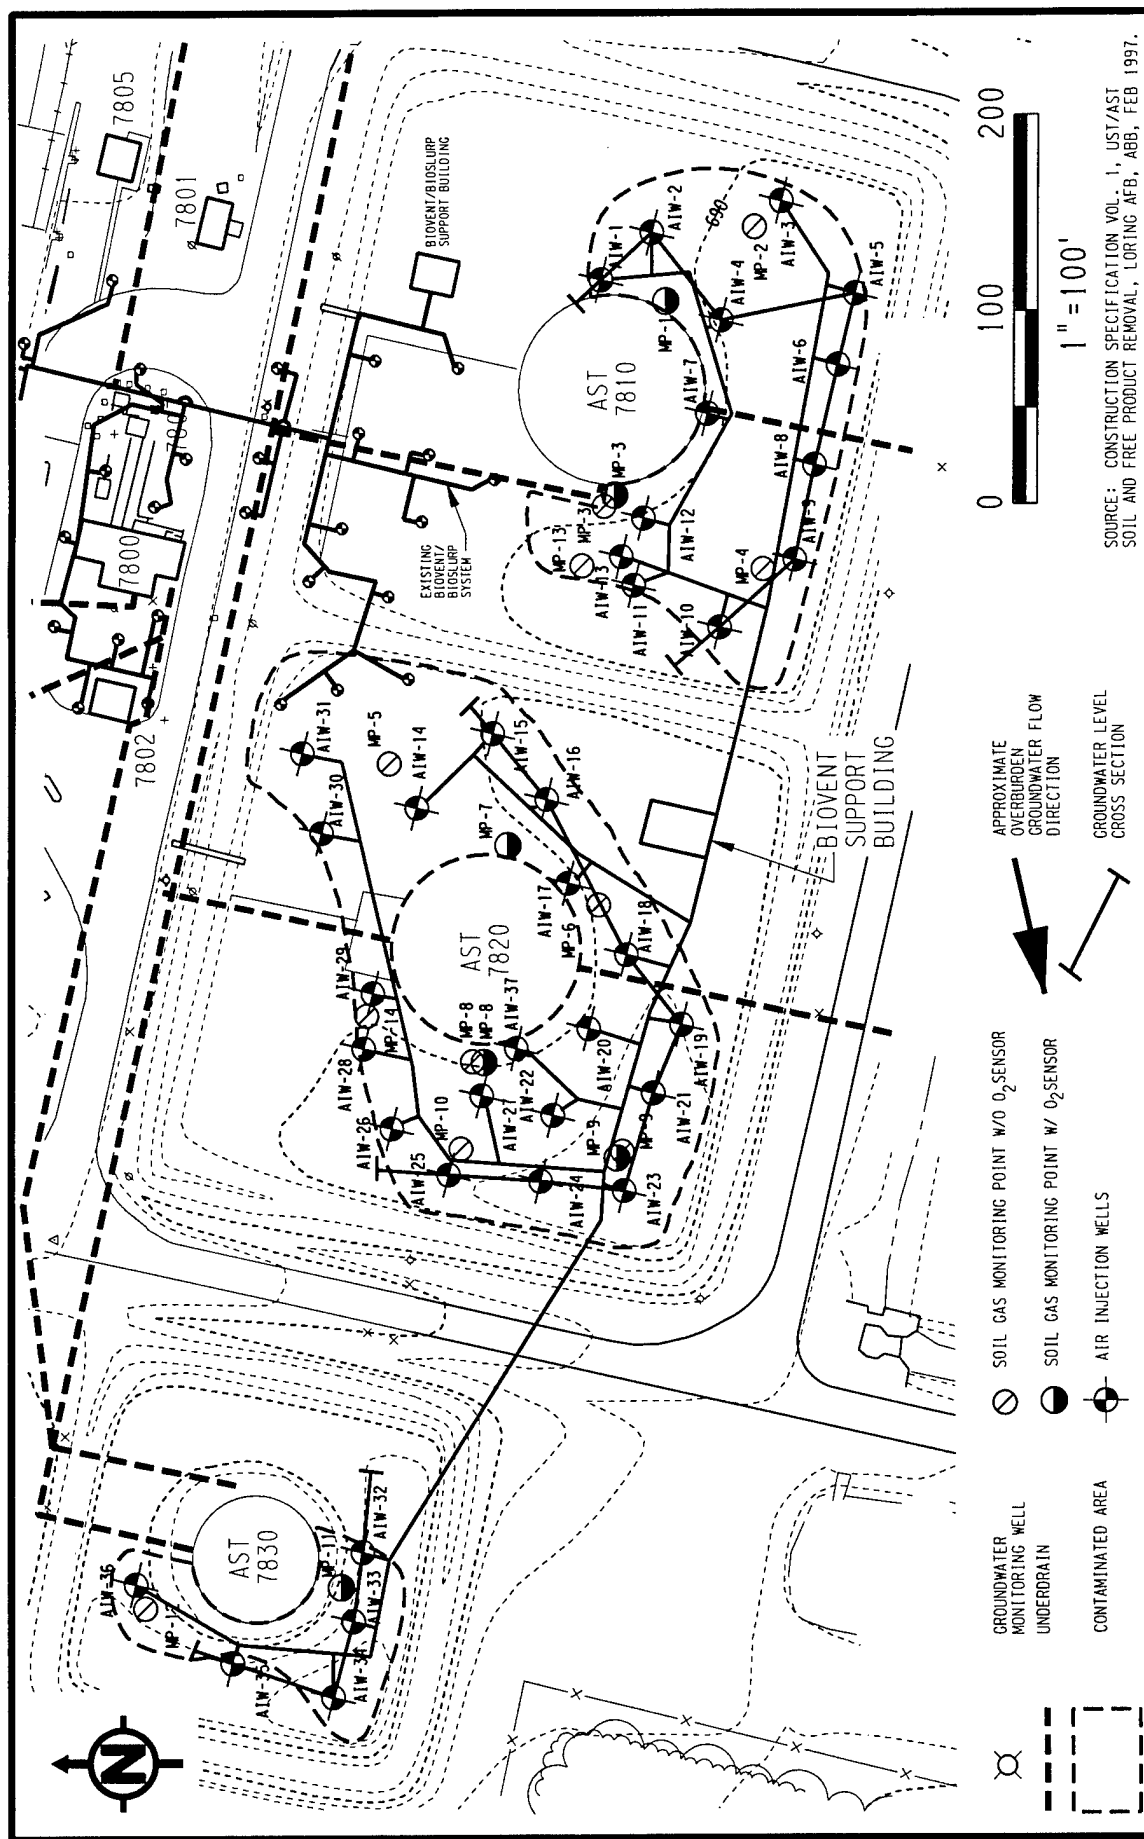
Figure 10-1
Air Injection Wells and Monitoring Points Location
Fuel Tank Farm II, LAFB

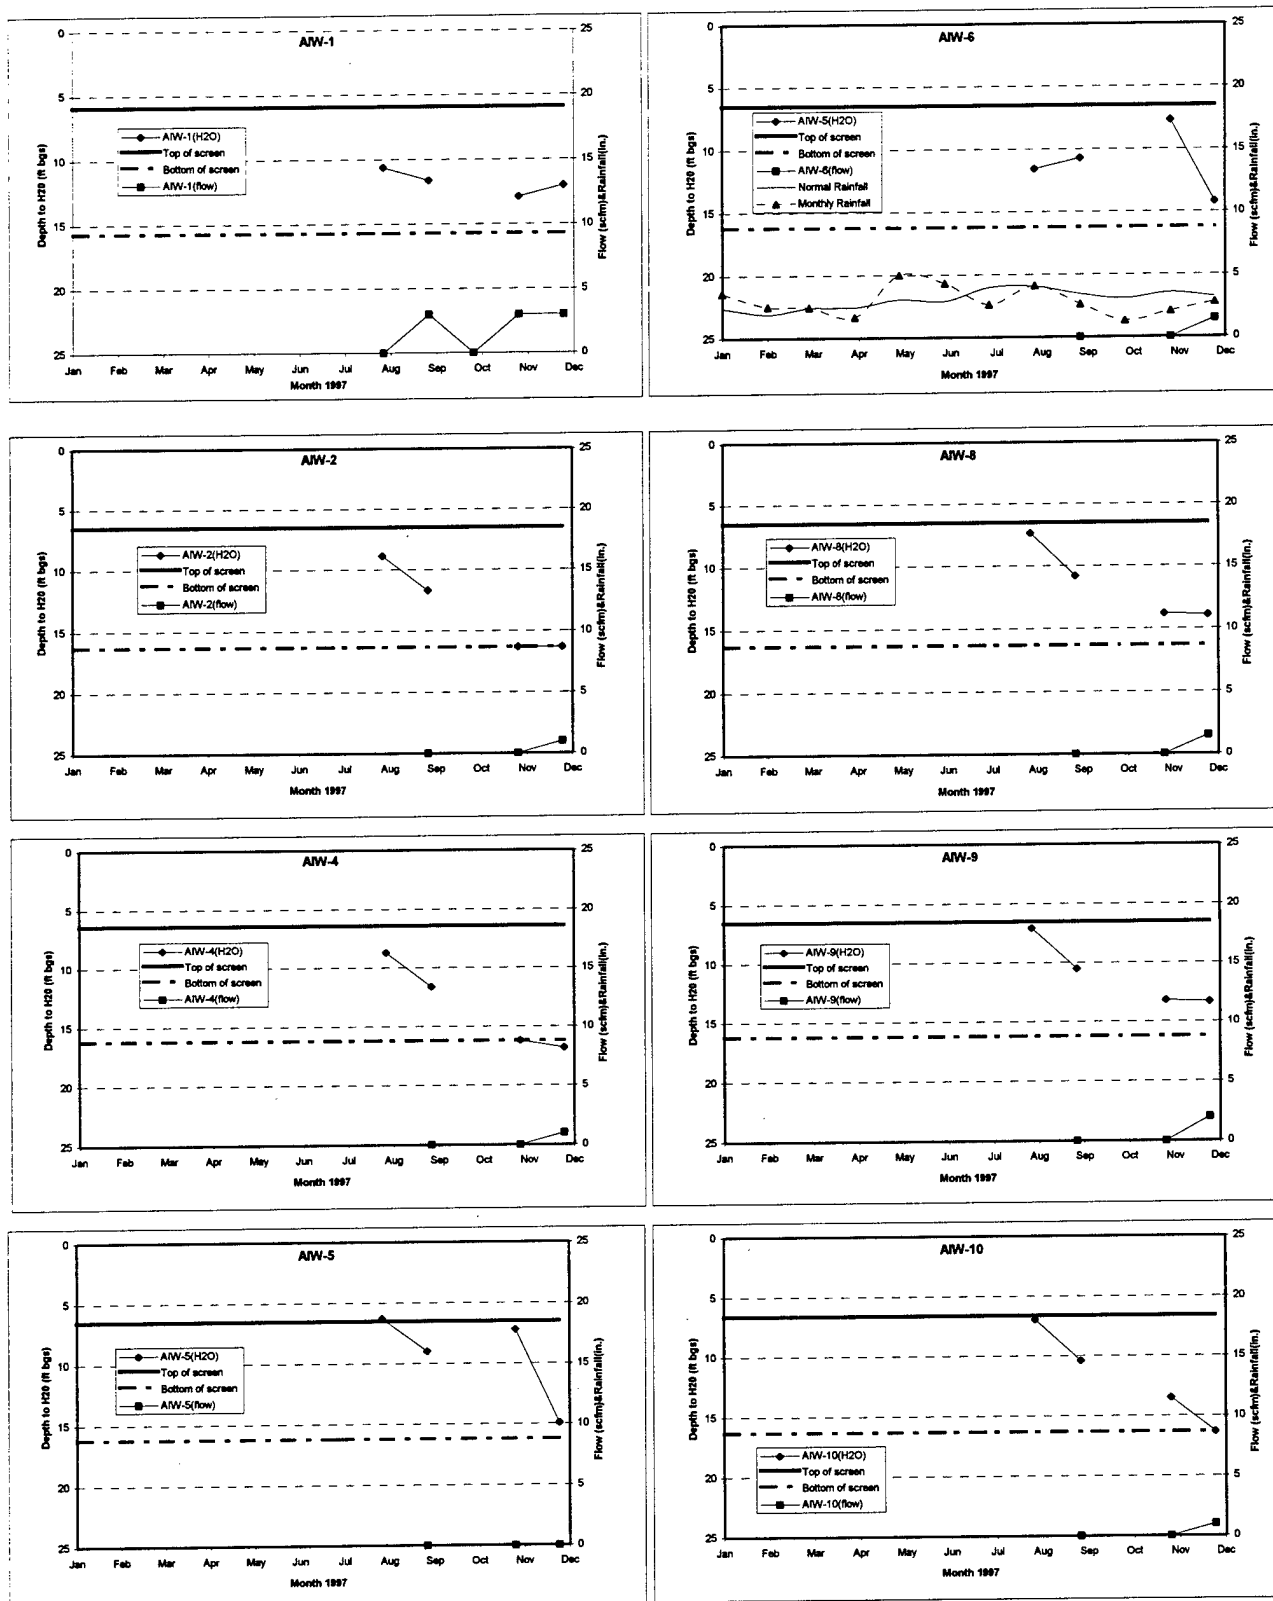
Figure 10-2 FTF II Groundwater/Air Flow Relations - AST 7810 Area

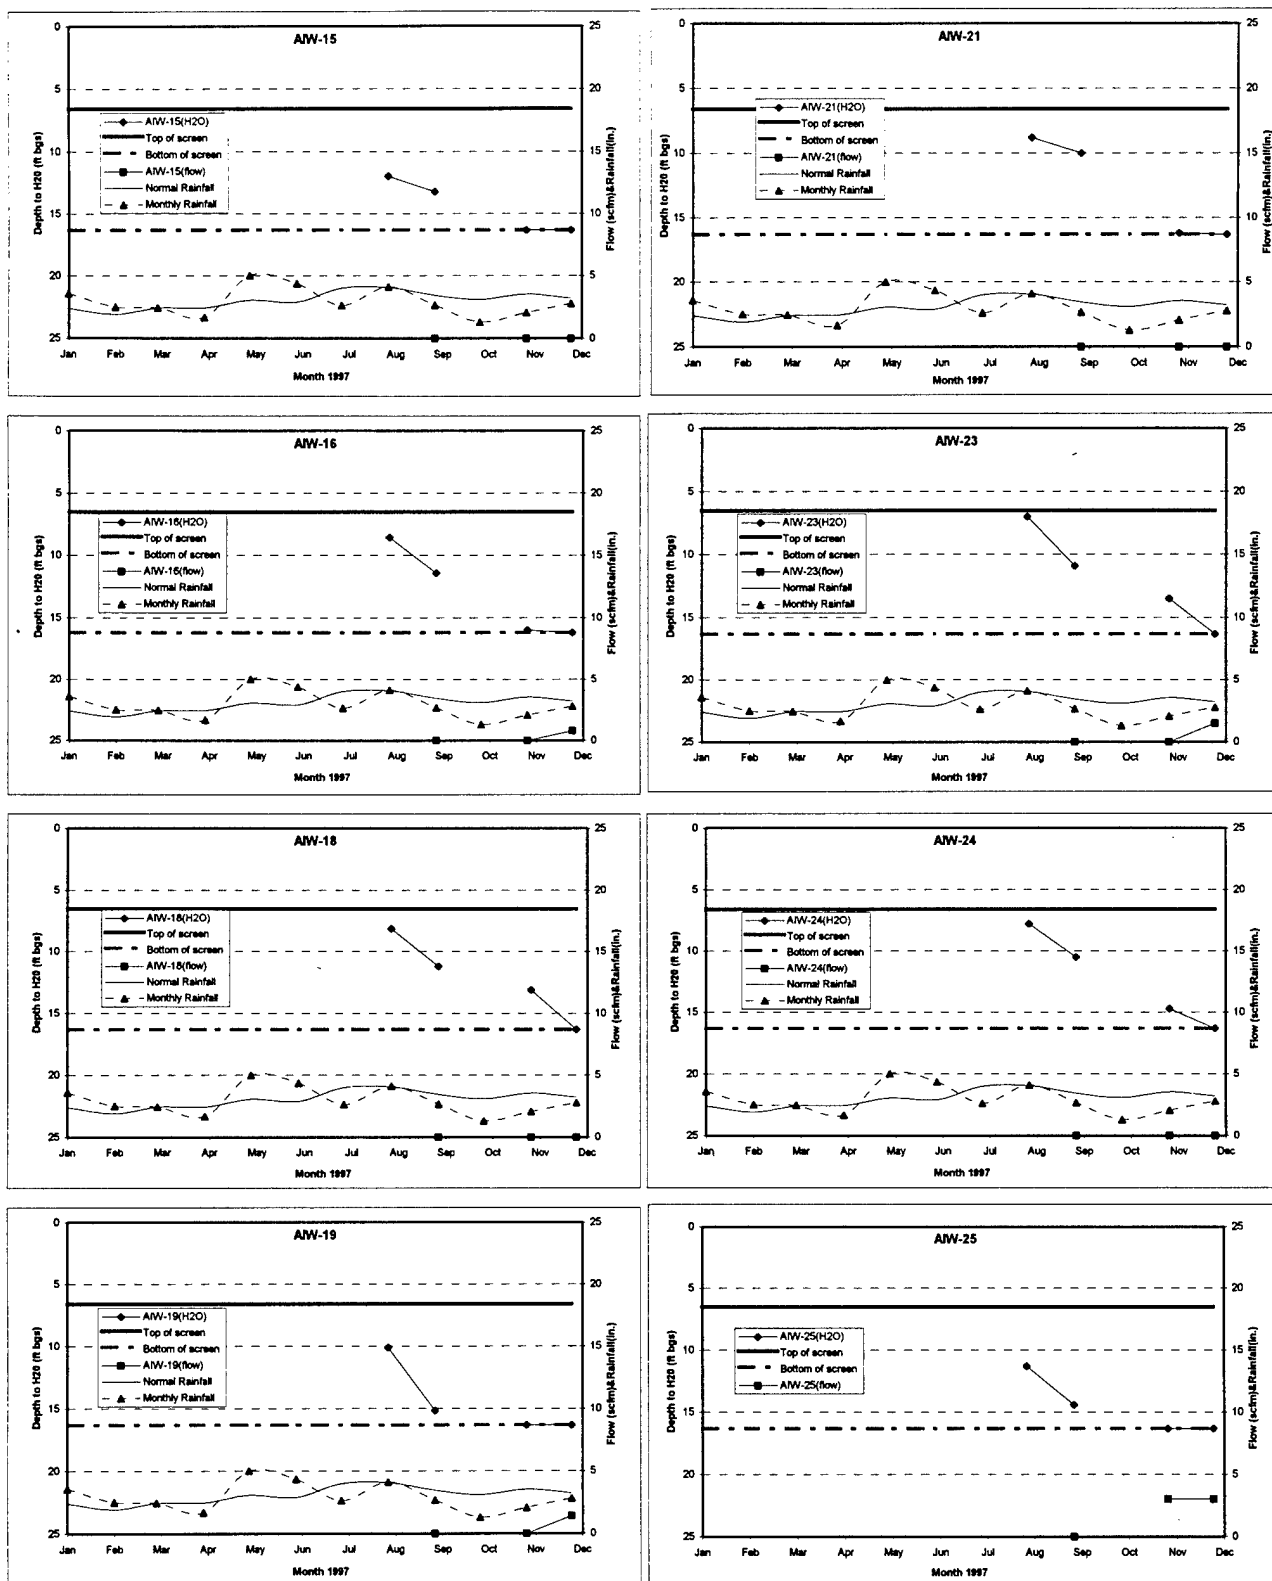
Figure 10-3 FTF II Groundwater/Air Flow Relations - AST 7820 Area

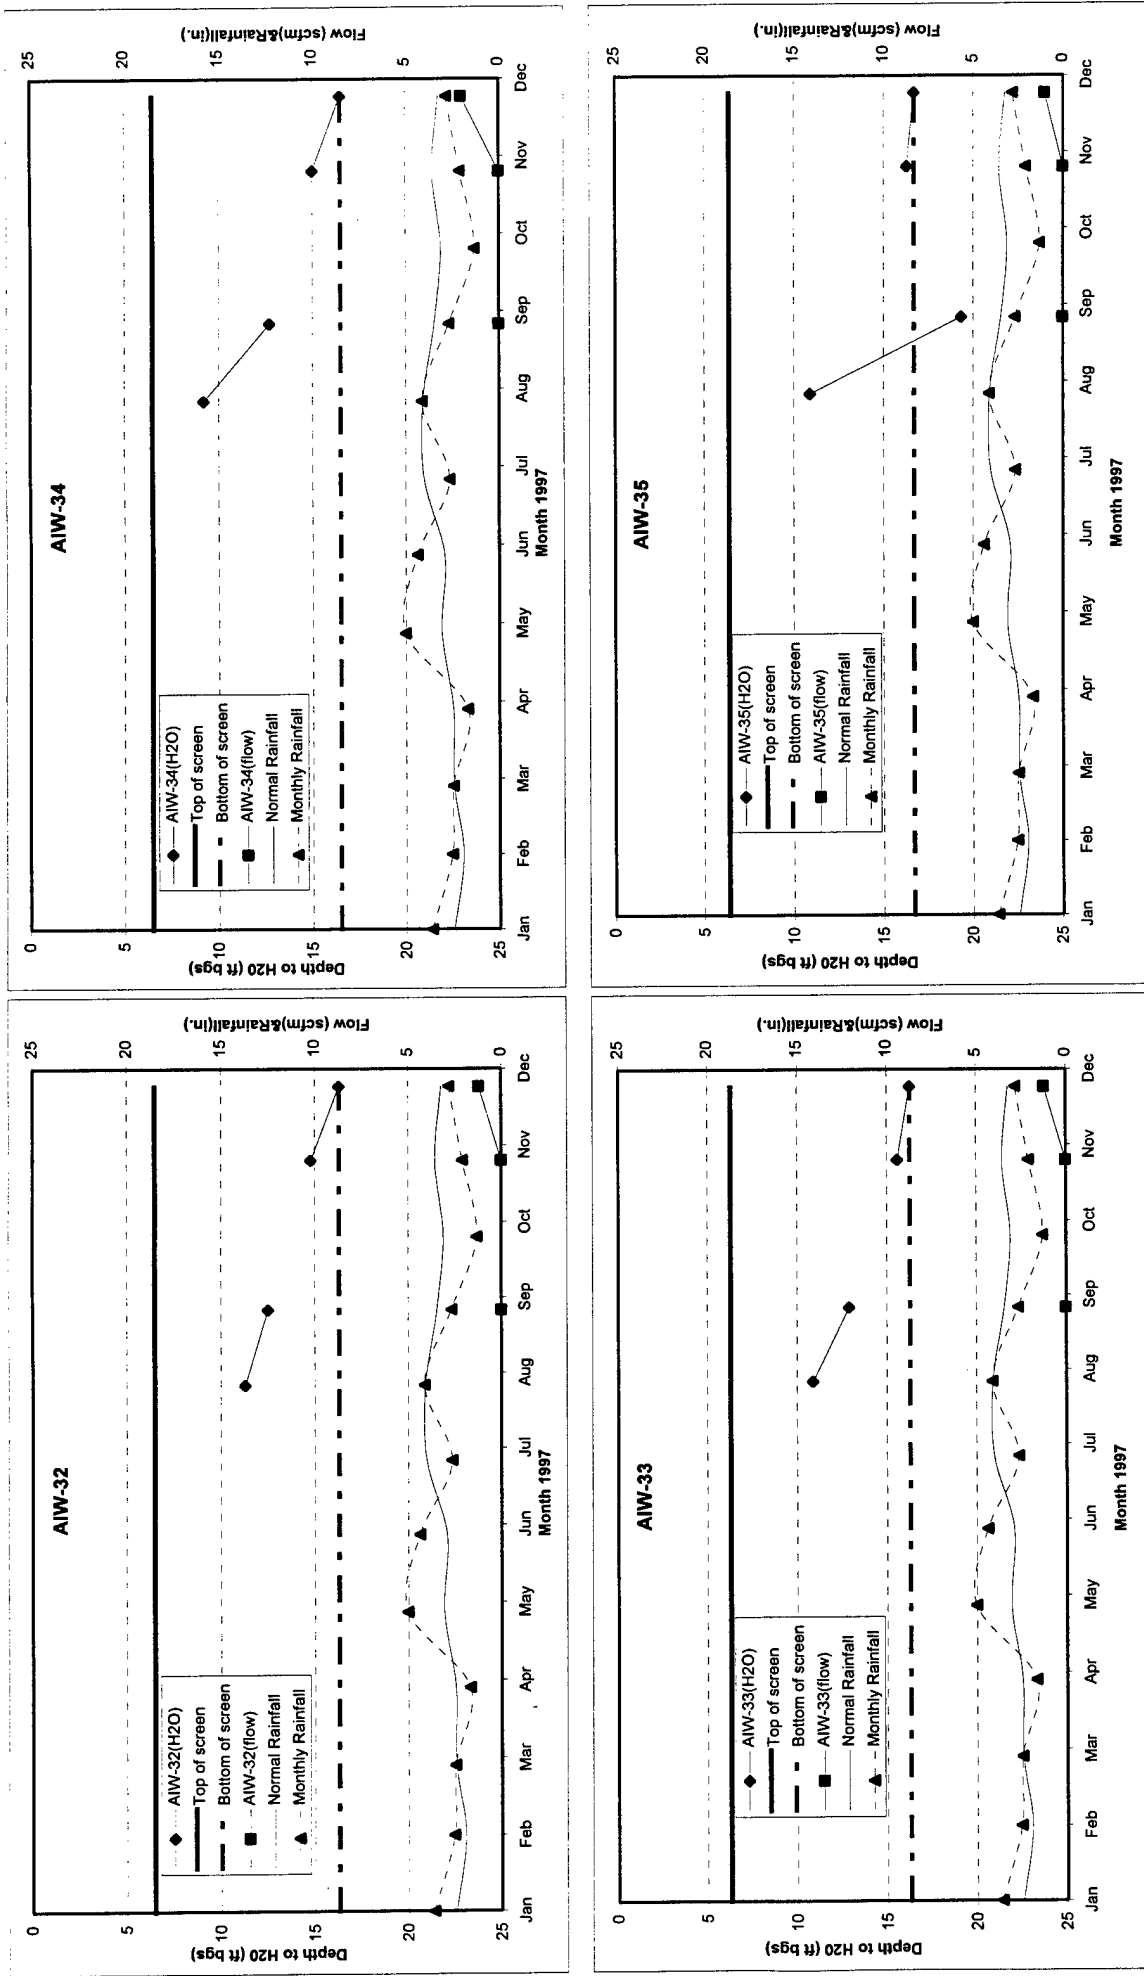
Figure 10-4 FTF II Groundwater/Air Flow Relations - AST 7830
